# Laclede's Landing

public realm implementation plan

Laclede's Landing Redevelopment Corporation

### **Planning Design Studio**

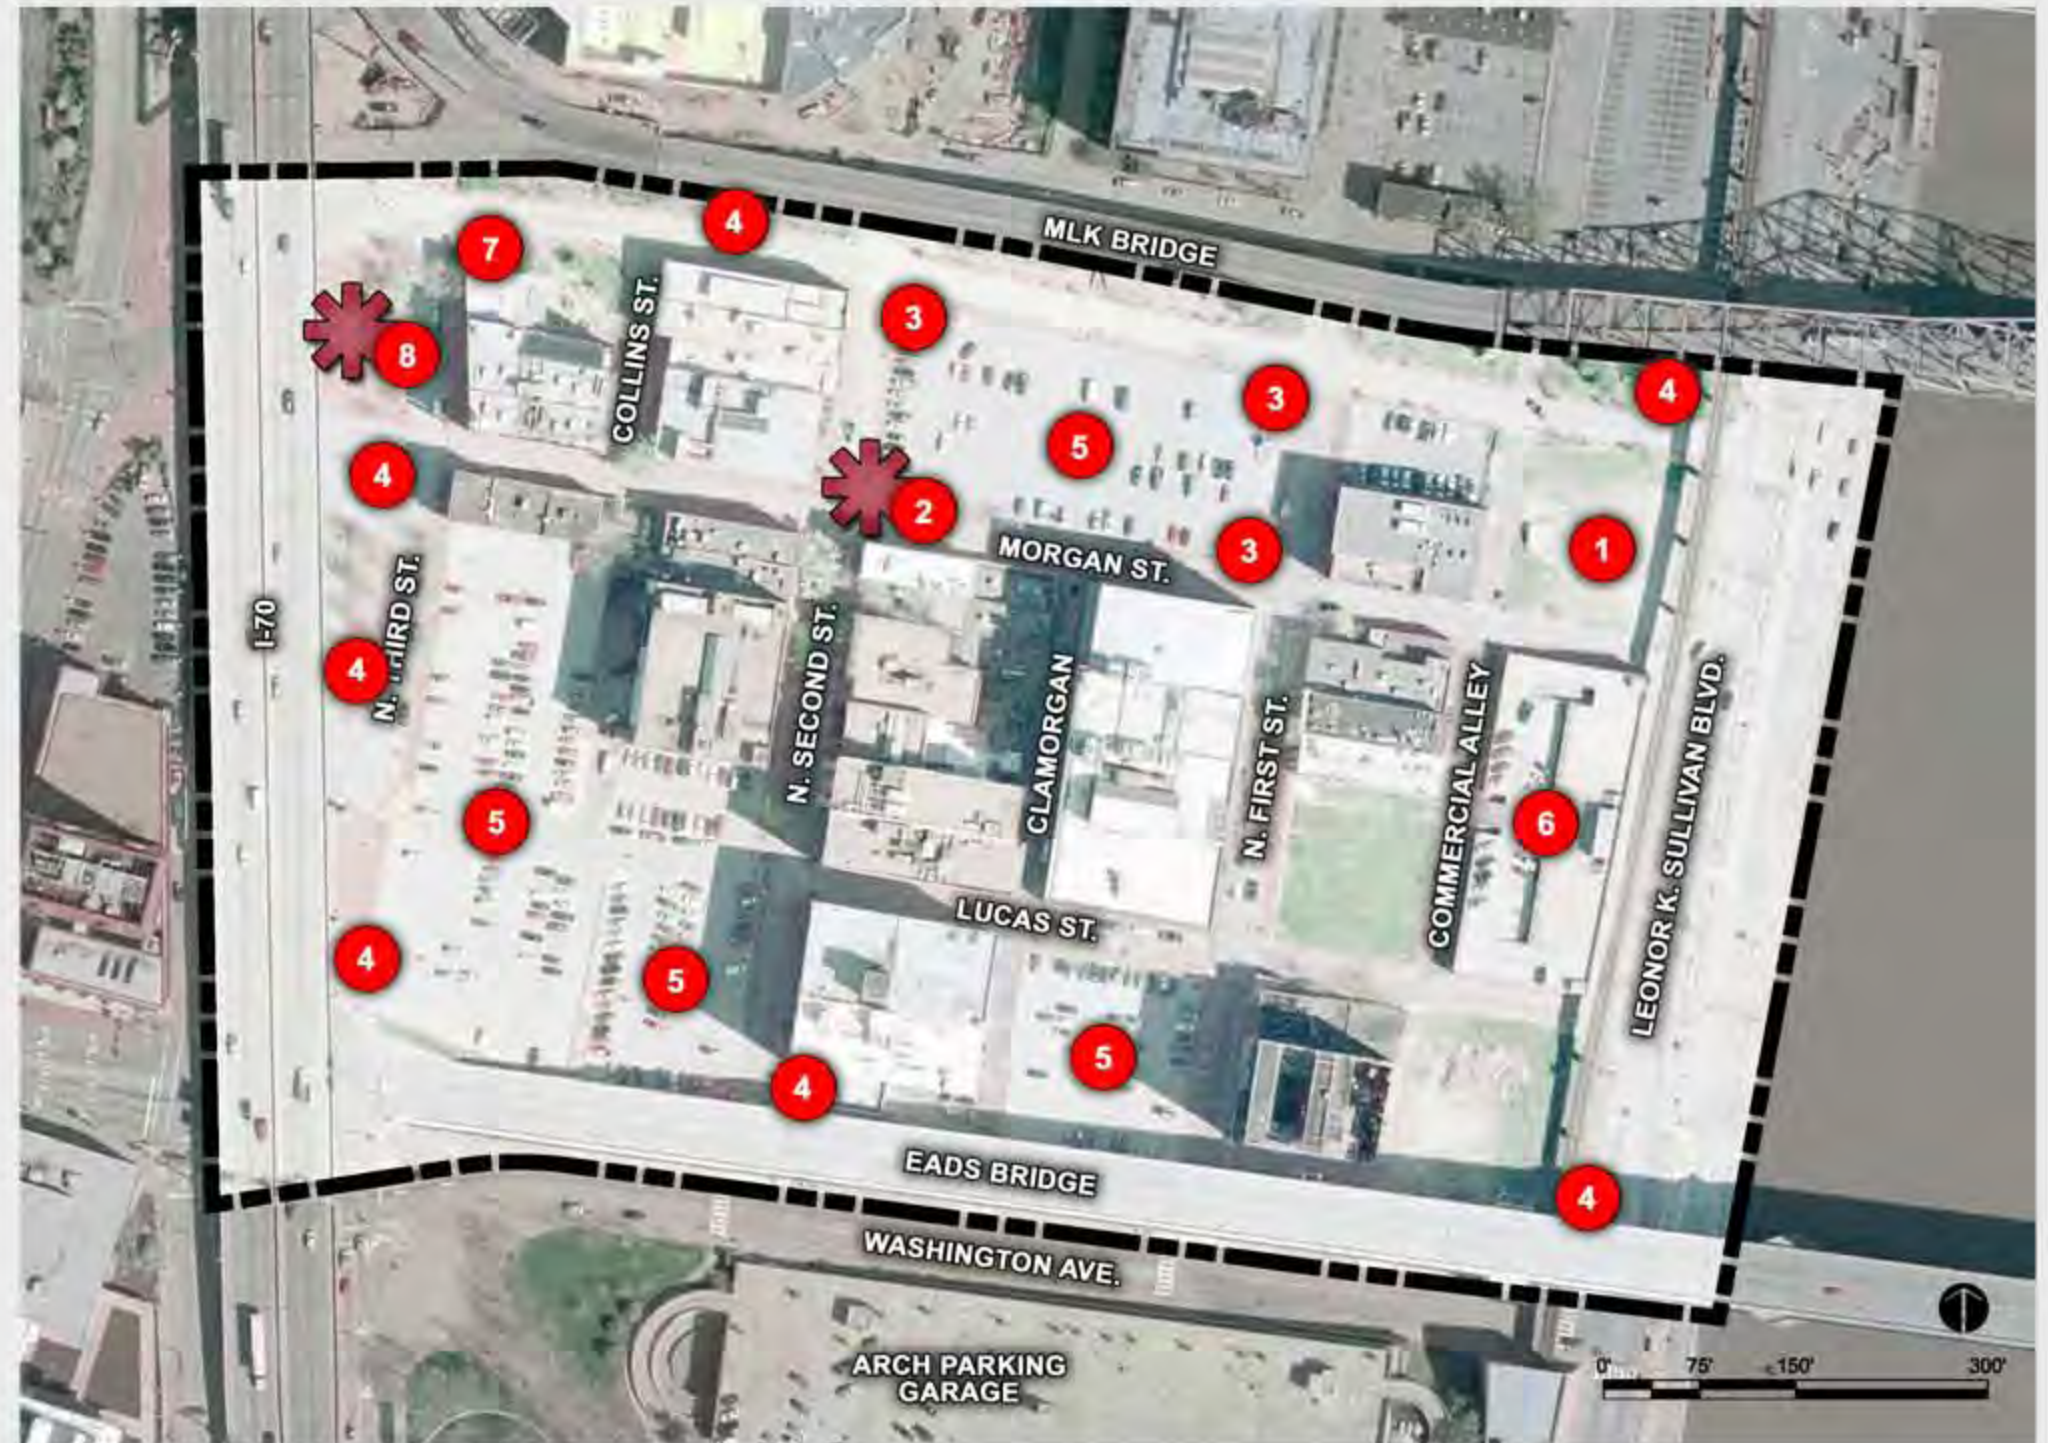
1. Proposed observation wheel location.
2. Moll's Clock Plaza – Nice pedestrian space accentuated by the historic clock. Street furnishings need replacement, along with additional benches.

3. Parking lot corner pedestrian spaces. Updated street furnishings and planting needed at various locations.
4. Public Art – Several pieces need renovation or replacement.

6. Riverfront Parking Garage – Needs permanent secondary flood access route. New top deck treatment with consistent period lighting and flagpoles with uplighting also needed.

7. Ladue Garden Club Pocket Park – Needs renovation and on-going attention to continue serving as a green space.
8. Existing Public Fountain – Needs to be renovated, or removed. A non-functioning fountain in this location projects a poor first impression.

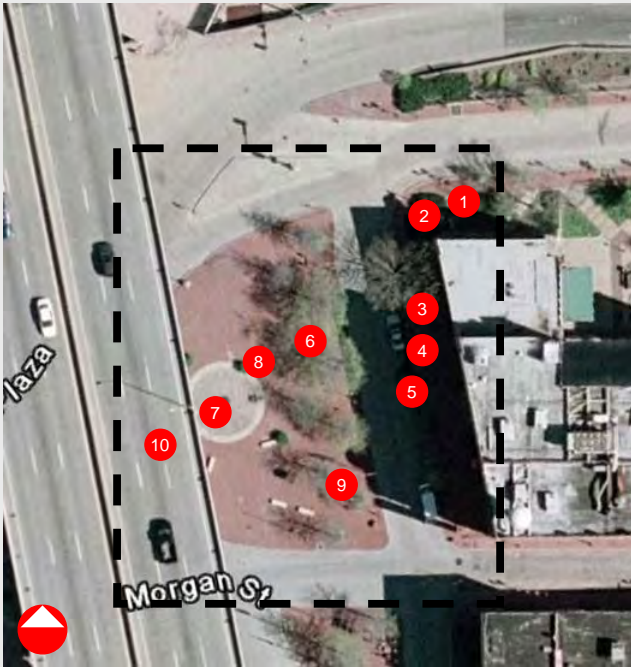
## Block 68W Third St.

3. Pedestrian pavement uneven and needs to be reset and benches need to be replaced.
4. Large open areas of sidewalk pavement present opportunities for outdoor dining in the future.

5. Trees which have been removed need to be replaced.
6. Pavement near existing mature trees needs need to be reset.
7. At-grade fountain is a nice feature, however it does not currently function. It should be renovated for use during the summer months or replaced with a different feature.

8. Adjacent fountain equipment housing needs to be repaired, replaced and/or relocated.
9. Existing directory needs to be moved to a more prominent location.

10. Area under I-70 overpass is unexciting and should be visually appealing to draw people into the Landing from Downtown.

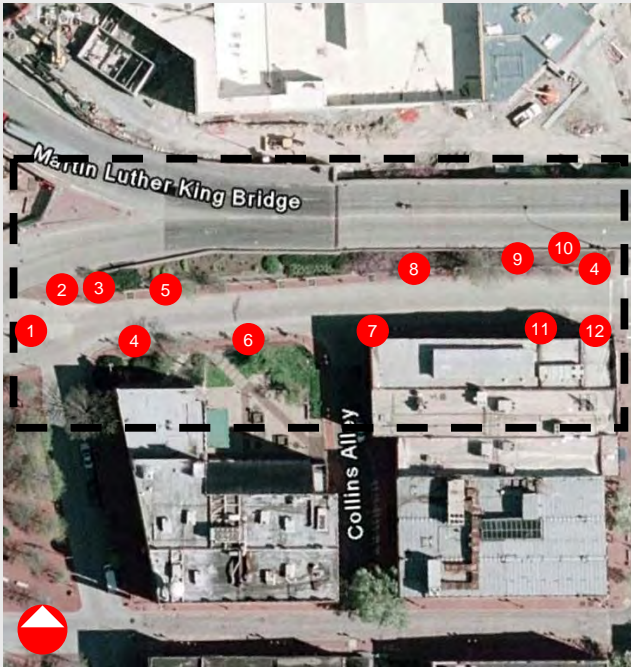
1. Concrete island should have brick pavers and planters installed in the future.
2. Potential area to relocate existing Laclede's Landing marquee sign.
3. Island planting should be renovated including demo of damaged ornamental fence.
4. Light pole base needs to be reset.
5. Planting area needs major renovation.
6. Newspaper box could be combined with existing mailbox in this location.
7. Corner walk is very narrow.
8. Cut off metal fence posts are a tripping hazard and should be removed.
9. Large trees block sidewalk.
10. Treatment of space under bridge should match treatment in Kassabaum Park with the exception of the fence.
11. Street trees block very narrow sidewalk.
12. Planter wall and trees in grates block walk. Consider removal of planter against building.

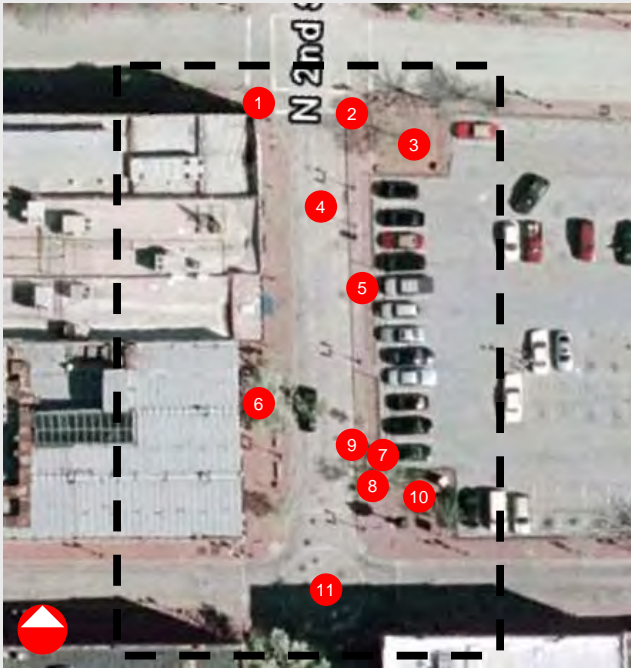
1. Corner sidewalk very narrow due to tight radius. Uneven pavement makes access difficult.
2. Electrical panels on wall are exposed and need screening.
3. Open planting beds should be replanted.
4. Existing lights block a very narrow sidewalk.
5. Exposed trash can should be stored within building envelope.
6. Sign pole blocks sidewalk.
7. Brick sidewalks have settled and need to be replaced.
8. Wood retaining walls failing and should be replaced.
9. Pavement around existing manhole has settled or is missing causing tripping hazards and effectively blocking the sidewalk.
10. Existing mature tree has overgrown planting area. A new planting area should be constructed to provide additional room for tree, or tree should be replaced.
11. Pavement around utility box has settled causing drainage problem and tripping hazard.

7. Existing electric meter in parking lot needs to be screened from view.
8. Uneven pedestrian paving at tree planting areas needs to be reset.
9. Street tree plantings needs to be replaced.

10. South Pedestrian Node assessment:
  - Replace shrub plantings and trees.
  - Provide shrub planting for buffering against existing parking lot.
  - Remove unused newspaper box.

- Replace benches.
11. Circular concrete band needs replacement and uneven intersection pavers need resetting.

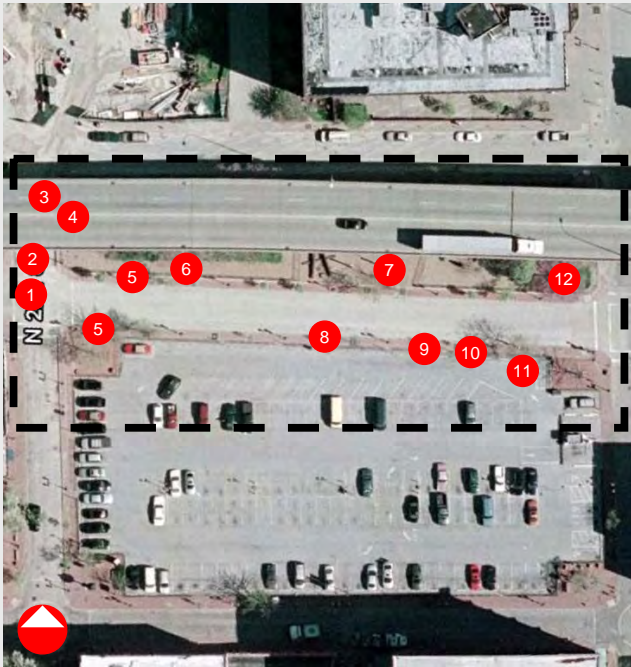
1. Light pole blocks walk at ramp.
2. Non standard street sign needs to be replaced to match others in Landing.
3. Transition between asphalt surface and cobbles needs to be created with a concrete band.

7. Kassabaum Park - Decorative metal fence helps visually establish character of the park.
  - Additional benches should be provided for users.
  - Pea gravel is a nuisance and should be replaced with smaller compacted rock with fines.

10. Curb stops at edge of parking lot are unattractive and should be replaced with curbing.
11. This portion of the parking lot is higher in grade than surrounding walk. Paved slope solution is unattractive.

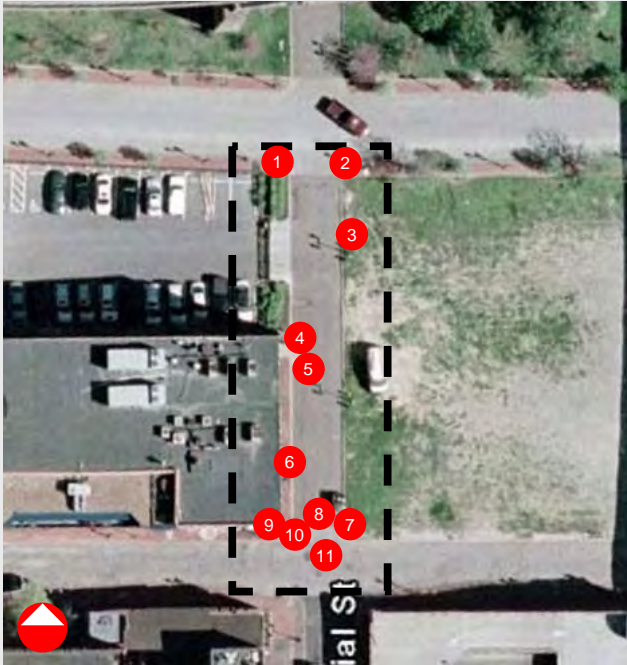
1. None compliant curb ramp, due to steepness, settlement and narrow width.
2. Brick settlement at curb ramp.
3. Square bollards should be repainted or replaced.
4. Open access doors should be secured with locks.
5. Dumpsters and trash cans in alley should be relocated inside the building envelope.
6. Paving generally in good shape, only minimal spot repairs needed.
7. Light fixtures and bollards block a very narrow sidewalk making it almost unusable.
8. Bollards adjacent to existing light pole need to be repainted, reset, or replaced.
9. Paving around bollard mounting plates needs to be reset.
10. Non ADA compliant ramp in poor condition.
11. Large concrete band needs repair.
12. Paving around existing manholes needs to be reset.

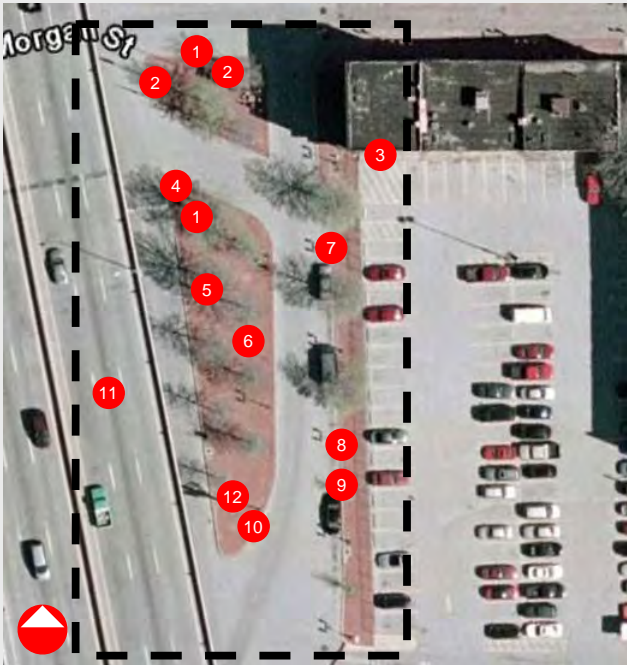
1. Ground mounted street sign missing.
2. Inlet/curb needs repair.
3. Transition between asphalt surface and cobble needs to be created with a concrete band.

9. Trees located in narrow walk adjacent to existing parking lot will be difficult to keep in this area.
10. Inlet and street sign create tripping hazard at sidewalk corner.

11. Wood retaining wall needs to be replaced.
12. Pavers at ramp need to be reset.
13. Cable and bollard barriers are ineffective and should be replaced with some other type of temporary barrier.

14. Graffiti should be removed from existing light pole.
15. Pohrer Park
  - Turf on ship berm is failing and starting to erode.
  - Signs on north side of park need to be straightened.

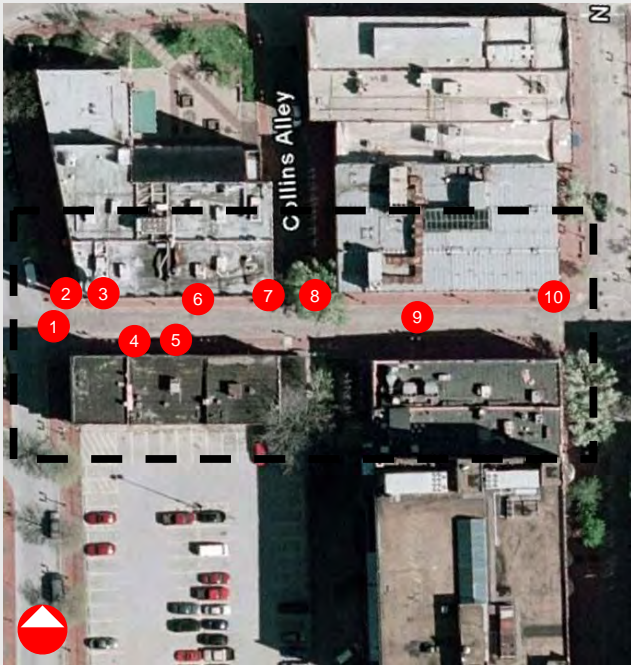
1. Transition between asphalt surface and cobbles needs to be strengthened with a concrete band.
2. Tight corner due to ramp and sign pole.
3. Marquee sign mounted on building has good visibility.
4. Wider sidewalk in this area could accommodate street trees in the future.
5. Sidewalk pavers missing at various locations.
6. Sidewalk very narrow and restricted by light poles installed in center of walk.
7. Missing pavers at manhole create tripping hazard.
8. Grade into alley restricts ADA access of walkway.
9. Cobble stones very uneven and need to be reset.
10. Bricks around utility box missing and need to be reset.

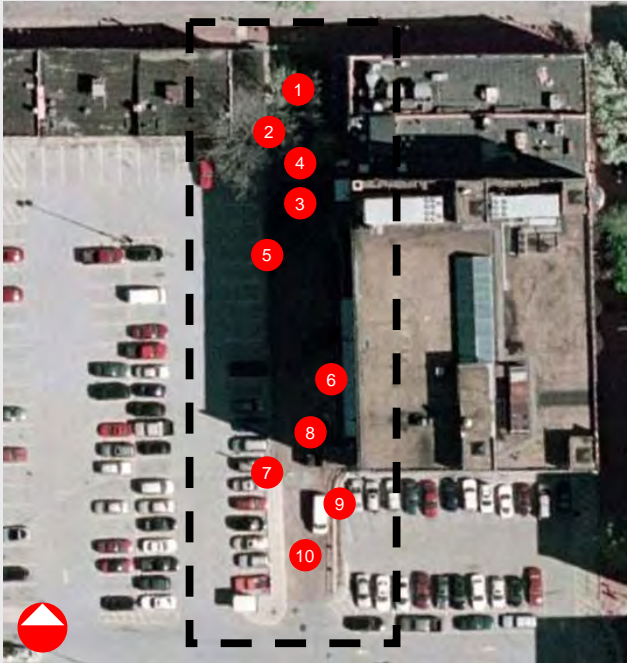
1. This portion of the alley has been converted into an outdoor dining patio with tables.
2. Concrete retaining wall is failing and should be replaced.
3. Exposed dumpster should be located within the building envelope.

4. Alley is permanently blocked by decorative metal/wood/bamboo fence.
5. Concrete retaining wall with chain link fence which is leaning and should be replaced with fence matching other parking lots. Alley is also blocked by temporary fence barrier.

8. Dumpster located in alley. Needs to be relocated within building envelope.
9. Make shift yellow handrail should be replaced or repainted black to match other site furnishings.

10. Alley cobbles in poor condition. Need to be reset. Area is used as parking spaces which blocks access.

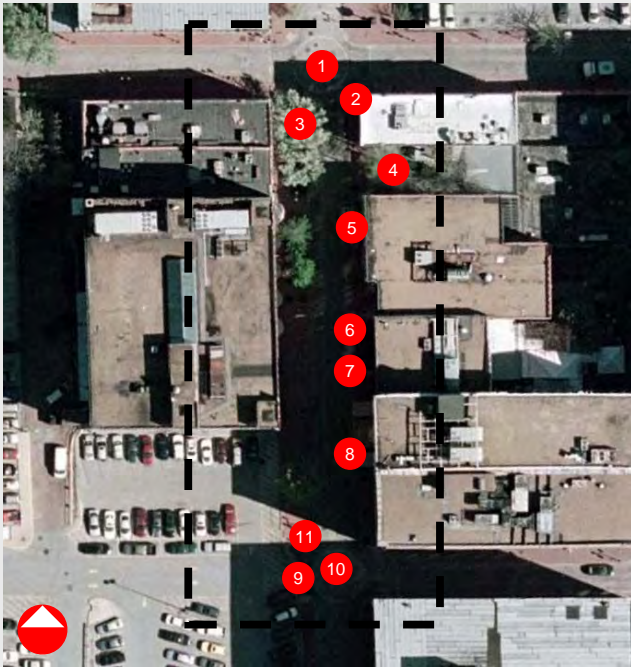
1. Intersection paving very uneven. Cobbles need to be reset.
2. Steep and narrow corner ramp does not meet current ADA guidelines. Curbing also needs to be replaced.
3. Nice overhead canopy trees create a very desirable outdoor sidewalk/dining environment.
4. Mesker Park nice outdoor space however, it has been incorporated into Big Daddy's Bar.
5. Replacement trees are needed on this side of street.
6. Planters could be utilized to create a small outdoor dining area in this location.
7. Benches need to be replaced in this location. Signs should be straightened.
8. Handicap ramp needed on this side of street opposite existing ramp.
9. Opportunity for creating a pedestrian linkage through parking lot utilizing existing Lucas Ave. R.O.W.
10. Intersection paving very uneven. Cobbles need to be reset.
11. Steep handicap ramp.

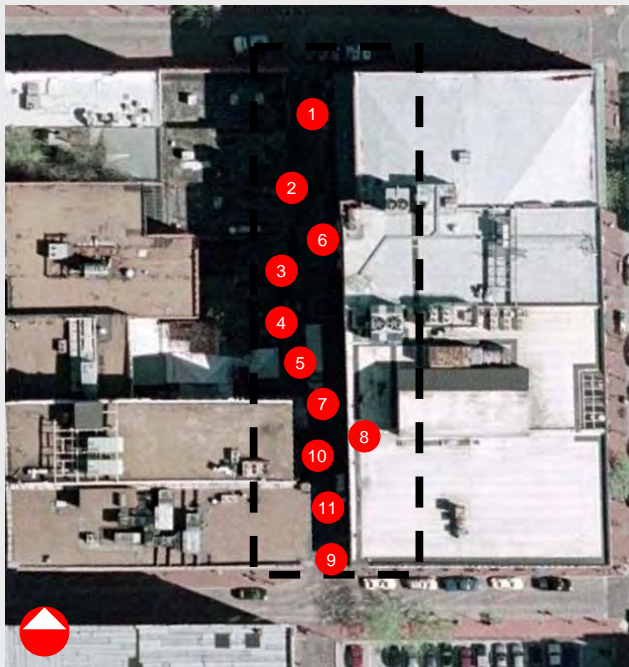
2. Unscreened dumpsters which should be located within the building envelope.
3. Pavement has settled or is missing adjacent to manholes creating tripping hazards.

7. Paving bricks missing at various locations, and should be replaced.
8. Nice Informal seating area, however dumpsters make area unpleasant for users.
9. Steep transition to adjacent sidewalk. Alley drainage rarely exists center of alley. Alley needs to be properly pitched or permeable pavement should be utilized.

10. Additional landscape material should be incorporated onto alley.
11. Dark pavement adjacent to brick buildings contributes to urban heat island effect. Lighter colored pavements will reflect heat during summer months.

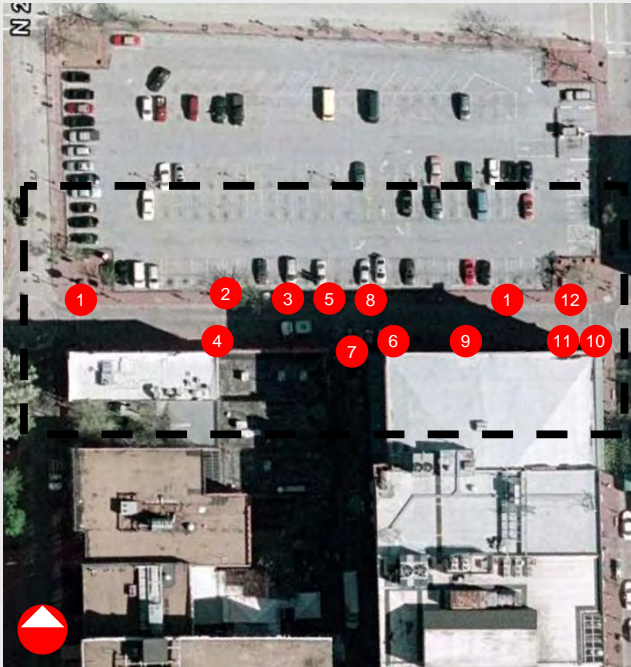
## Blocks 25 & 26 Morgan St.

1. Street trees needed on this side of street.
2. Trees heaved heaved surrounding pavement and tree grates. Several tree planting areas have missing or loose cobbles edges.
3. Newspaper box should be moved to a consolidated location with other boxes.
4. Various utility boxes need to be adjusted flush to grade.
5. Directory sign needs repainting and updated map.
6. Benches needed on this side of sidewalk.
7. Missing pavers in alley need to be replaced at various locations.
8. Banner pole adjacent to parking should include a flag pole for added visual interest at parking lot opening.
9. Missing pavers need to be replaced at various locations.
10. Various sign poles need to be repainted and straightened.
11. Traffic control gate should be painted black to match surrounding fixtures.
12. Curb needs replacement at various locations.

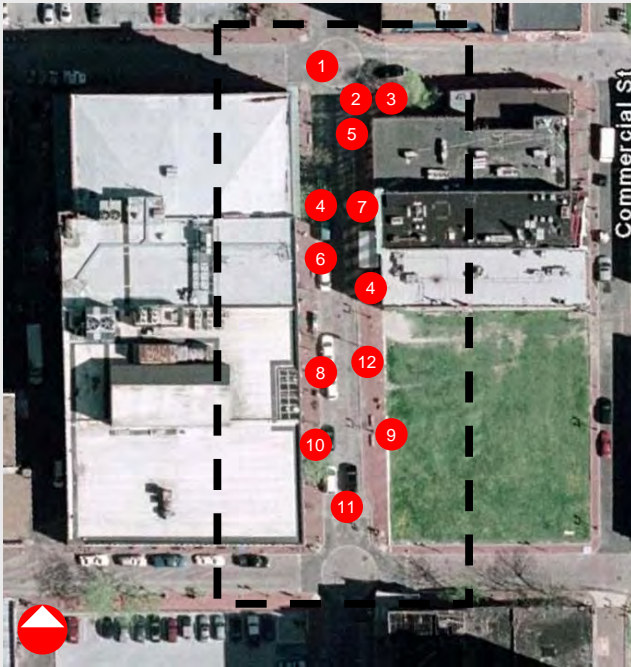
1. Intersection paving very uneven. Cobbles need to be reset and concrete banding should be replaced.
2. Brick steps should be rebuilt. Uneven pavement near steps needs to be reset.
3. Planting bed tie walls need replacement and the plantings need replacement.
4. New street trees are needed on both side of the street.
5. Paint and straighten sign poles.
6. Consolidate paper and delivery boxes into one location.
7. Additional planters would improve outdoor dining experience. Planters should match other site furnishings.
8. Multiple valve boxes need to be reset throughout area.
9. Existing benches need to be replaced.
10. Pedestrian pavement has settled and needs to be reset.
11. Handicap ramp needed on this side of street opposite existing ramp.
12. Existing banner poles should incorporate flags where possible.

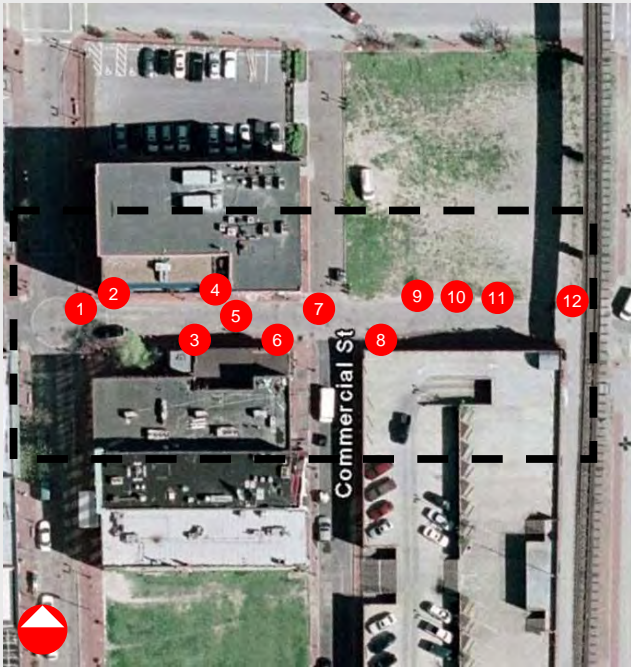
1. Concrete band is major traffic barrier and should be replaced.
2. Missing light fixture needs to be replaced.
3. Sidewalk has width on this side of street to accommodate new street trees.

6. Pavement has settled around existing utility structures creating tripping hazards.
7. Asphalt overlays should be removed from street cobble stones and cobbles should be reset to create even driving surface.

8. Street trees could be added where sidewalk is wider on this side of street.
9. Existing granite curb.
10. No sidewalks exist on this side of street.
11. Non standard parking sign pole, should be replaced with consistent pole.

12. Cable and bollard barriers are ineffective and should be replaced with some other type of temporary barrier.
13. Silt collecting in this area due to erosion from adjacent vacant site.

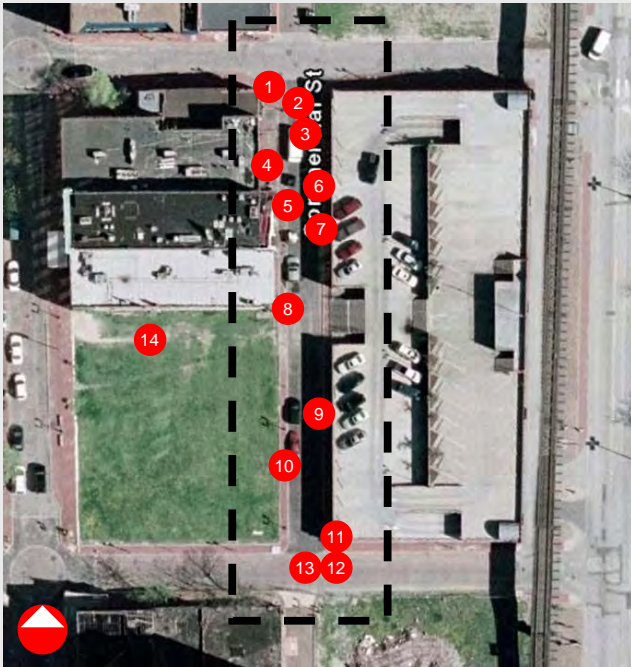
10. Wooden retaining wall failing and in need of immediate replacement.
11. Major pavement/sewer replacement needed.
12. In-ground street sign replacement needed.

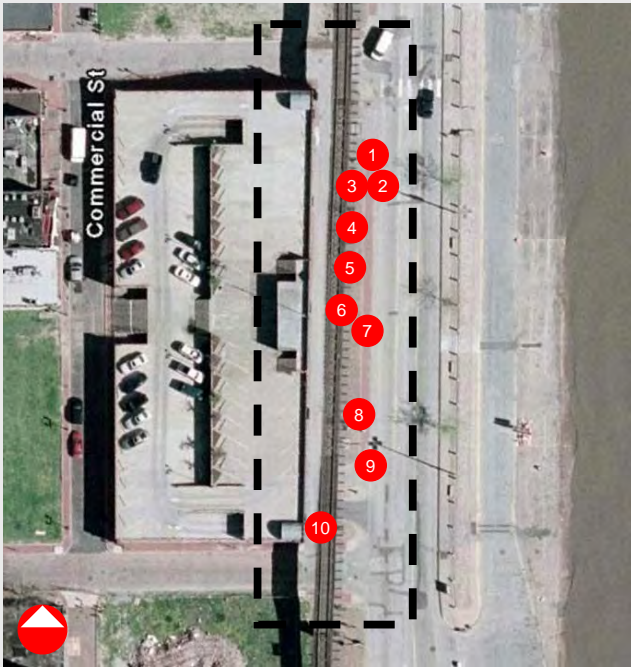
- Existing sign pole is bent, needs painting and should be replaced.
- Brick paving at fire hydrant needs to be reset.
- Existing damaged parking stops project a poor image.

- Consider adding pedestrian level lighting to garage piers to provide additional ambient lighting in this area.
- Cobblestone joints in pavement are too wide, making walking difficult and potentially unsafe. Cobbles should be reset.

- Missing cobblestone should be replaced at various locations.
- Brick sidewalk has settled and does not adequately drain. Mud is covering sidewalk at several locations.

- Parking garage sign needs painting. Consider a new sign designed to match character of Laclede's Landing marquee signs. A directional sign at this location would help improve visitor orientation.

- Remove existing curb and replace with roll type curb at parking garage entrance.
- Temporary parking price sign blocks ADA access. Consider incorporating price information to existing pole sign, described above.

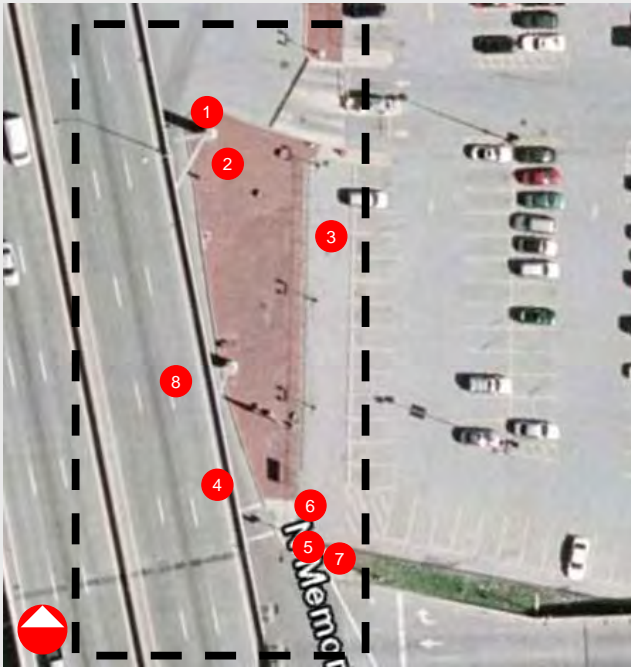
1. A pedestrian oriented terminus is needed at the end of Lucas Street.
2. Circular concrete band needs replacement and uneven intersection pavers need to be reset.

3. Large concrete band with ADA ramp on one side but straight curb on opposite side.
4. Street pavement is rutted and in very bad condition. Needs cobble stone reset.

5. Benches in this area are missing and need to be replaced. Plant larger trees in a continuous bed to provide improved growing conditions. Replace missing tree grate or add plantings to open area.

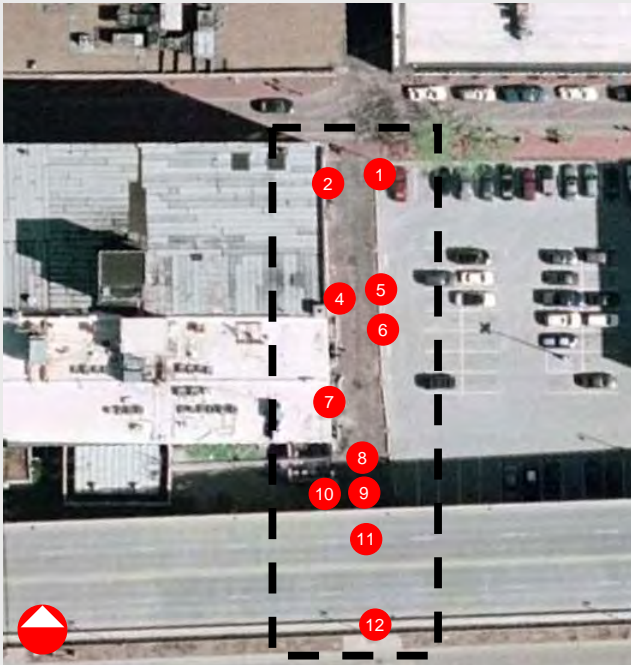
1. Poorly defined edge of parking lot. No buffer or screening.
2. Temporary wood stairs should be replaced with permanent brick solution.
3. Utilities are generally well screened in this alley.

4. Alley pavement has been patched with concrete and asphalt in various locations. Patches should be removed and replacement brick pavers installed.
5. Bollard and cable barrier projects poor impression. Replace with black metal fence similar to that on other edges of the adjacent parking lot.

9. Inlet is in poor condition, and pavement around storm inlet has settled preventing adequate drainage.
10. Poor view into utility service area. Needs to be screened.

11. Area beneath Eads Bridge is dark, and filthy. Overhead structure should be modified to prevent accumulation of pigeon droppings.
12. Consider adding attractive entry signage to Eads Bridge structure at portal entrance.

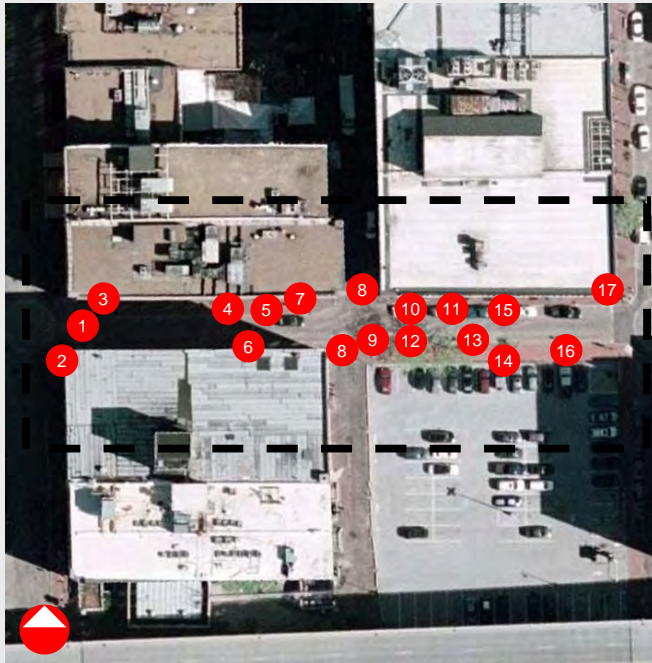
1. Cobble street pavement very uneven, resetting needed.
2. Fire hydrant blocks corner sidewalk access.
3. Valve boxes and horizontal street signs create multiple tripping hazards.

7. Abandoned sign post should be removed or utilized.
8. Alley pavement surface in poor condition with steep cross slope.
9. Uneven pavement at all manholes is a serious tripping hazard.

10. Inlet grate is a tripping hazard and needs replacement.
11. Street light placement in center of sidewalk seriously compromises usefulness of sidewalk.

15. Multiple grates combined with street light placement make walking difficult.
16. This sidewalk has additional width to accommodate trees and street lights.

17. Sidewalk constriction point due to narrow sidewalk and light pole location.

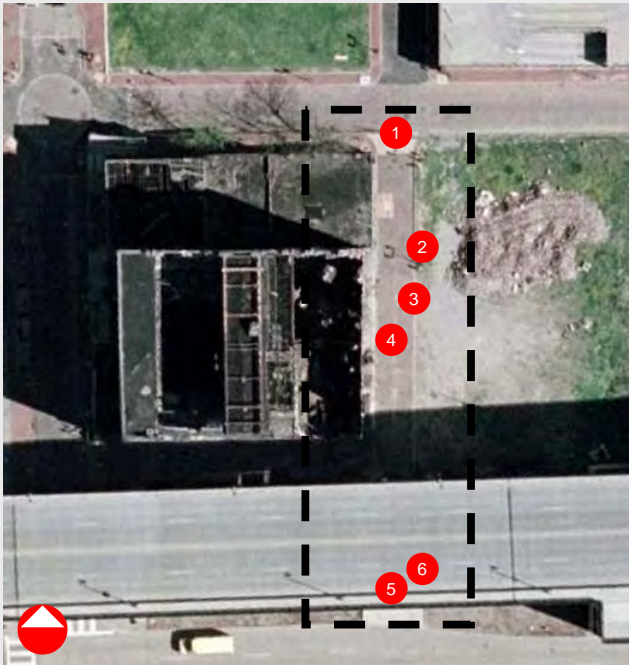
1. Access to alley is completely restricted due to a construction fenced placed around the Switzer Building site.
2. All pedestrian lighting has been removed from this alley during the demolition of the Switzer Building. Lighting which matches the historic lighting used throughout the Landing should be used as replacement lighting.
3. Only a small portion of the existing alley curbing remains. New curbing should be installed when property is redeveloped, or when construction fence is removed.
4. Alley pavement is generally in good shape and does not need replacement.
5. Eads Bridge portal is clean but needs graffiti removal and painting. Consider adding attractive entry signage at portal entrance.
6. Replace missing lighting fixtures to provide adequate lighting in portal area.

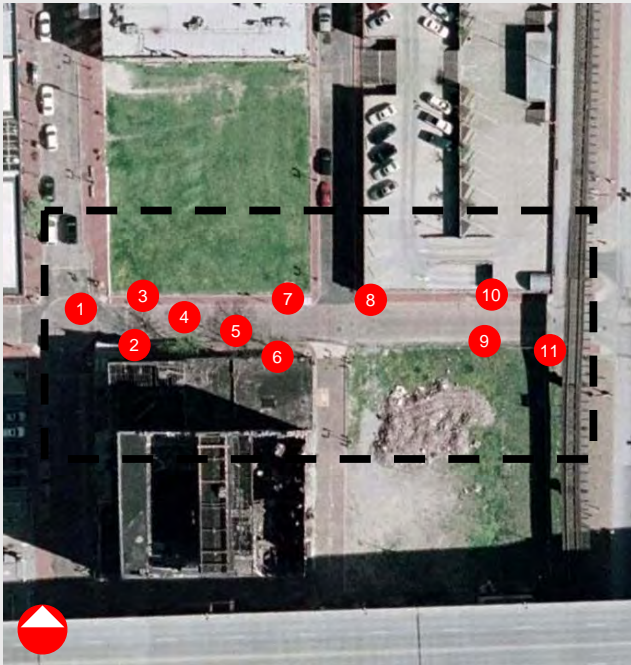
6. Remaining building foundation wall will need remedial work to make it safe for pedestrians.
7. Existing inlet needs to be lowered to meet surrounding pavement grade.

8. Garage downspout and adjacent light pole make walkway very narrow and difficult for pedestrians.
9. Sidewalks and curb do not exist in this area.
10. Sidewalk adjacent to garage lacks adequate width due to light poles located in the middle of sidewalk, and does not meet ADA width guidelines.

11. Electric boxes need to be reset flush to surrounding pavement to eliminate tripping hazard.

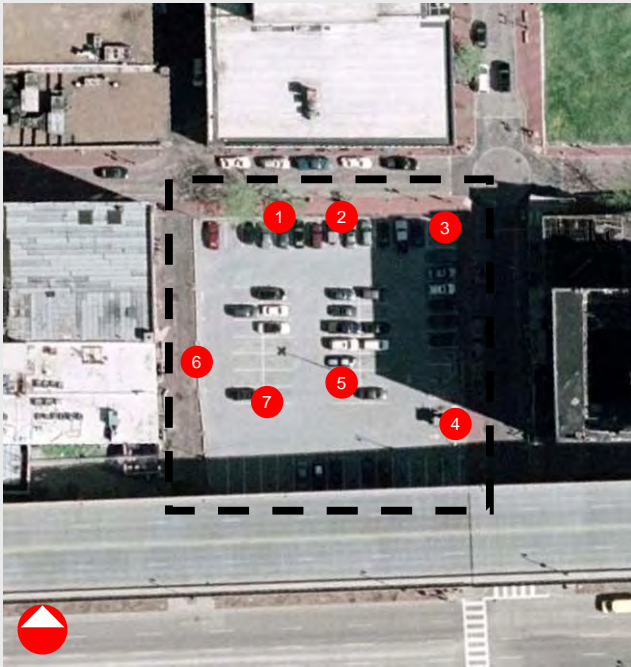
1. Pedestrian opening hard to see due to no upright elements are used to mark the opening.
2. Asphalt curb edge is disintegrating and needs to be replaced
3. Potential corner for planting. Since storm drain is in this area, bio treatment could be utilized.
4. Attendant booth should reflect some elements of architectural style of area. Signage should be consolidated for improved legibility. Lighting at booth is a major source of glare.
5. High mast light fixture is not in character with other light fixtures used throughout the Landing.
6. Cable barrier prevents pedestrian access from this side of lot. Barrier also presents poor first impression of the Landing.
7. Planting islands should be incorporated into end islands of lot.

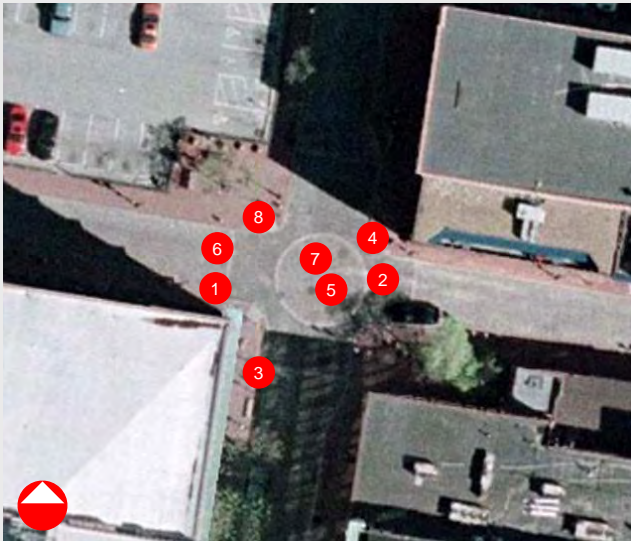
1. Existing swing gate should be painted black to match surrounding fixtures.
2. Paving bricks around existing manhole need to be reset and flush with concrete band and manhole. Circular concrete band needs replacement.
3. Existing planter should include tree for shade and to match surrounding tree planters.
4. Paving bricks need to be reset and flush with concrete band for accessibility. Sand and debris needs to be cleaned and maintained.
5. Cobblestone joints in pavement are too wide, making walking difficult and potentially unsafe. Cobbles should be reset.
6. Cobblestones around manhole need to be reset and flush with manhole. Concrete band needs replacement.
7. Adjacent fountain equipment housing needs to be repaired, replaced and/or relocated.
8. Existing plaza space a good refuge for pedestrians and source of shade. Enhance with additional plantings in tree planter.
