# Laclede's Landing

public realm implementation plan

Laclede's Landing Redevelopment Corporation

### **Planning Design Studio**

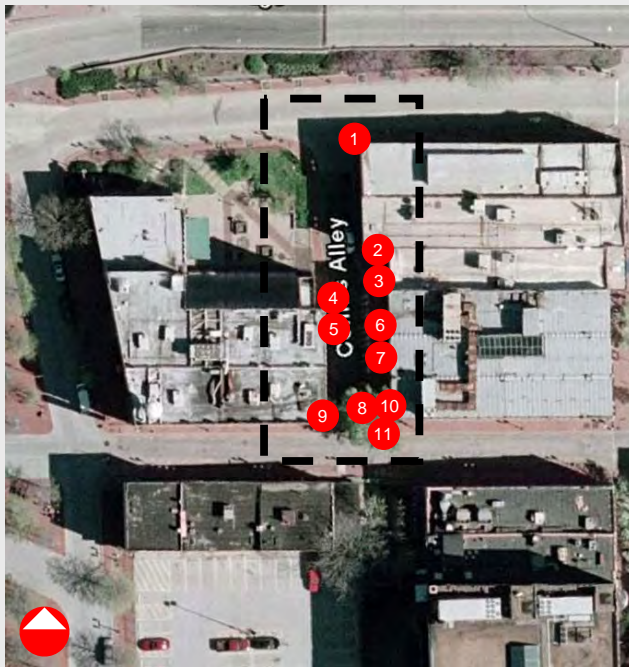
## Blocks 68W & 68E Collins Alley

1. Corner sidewalk very narrow due to tight radius. Uneven pavement makes access difficult.
2. Electrical panels on wall are exposed and need screening.
3. Open planting beds should be replanted.
4. Existing lights block a very narrow sidewalk.
5. Exposed trash can should be stored within building envelope.
6. Sign pole blocks sidewalk.
7. Brick sidewalks have settled and need to be replaced.
8. Wood retaining walls failing and should be replaced.
9. Pavement around existing manhole has settled or is missing causing tripping hazards and effectively blocking the sidewalk.
10. Existing mature tree has overgrown planting area. A new planting area should be constructed to provide additional room for tree, or tree should be replaced.
11. Pavement around utility box has settled causing drainage problem and tripping hazard.

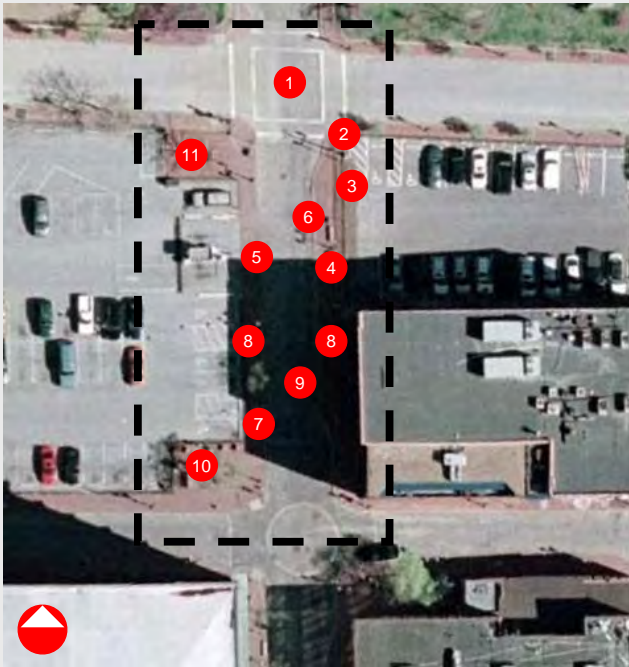
## Blocks 25 & 16W First St.

1. Laclede's Landing Blvd. is only concrete street in the landing.
2. Steep ramp does not meet current ADA guidelines.
3. Replace brick pavement header curb.

4. This section of the streetscape environment lacks planting. It has width to accommodate additional landscape planting
5. Curbing at parking lot entrance needs replacement. Drive apron creates steep cross slope with does not meet ADA guidelines.

6. All benches along street need replacement. Street trees are needed on both sides of street.
7. Handicap ramp needed on this side of street opposite existing ramp.

11. South Pedestrian Node assessment:
  - Create larger planting area around existing tree.
  - Add shrub planting against existing fence.
  - Reset uneven brick pavers.

- Install new benches.
  - Add a small curb wall to create grade transition.

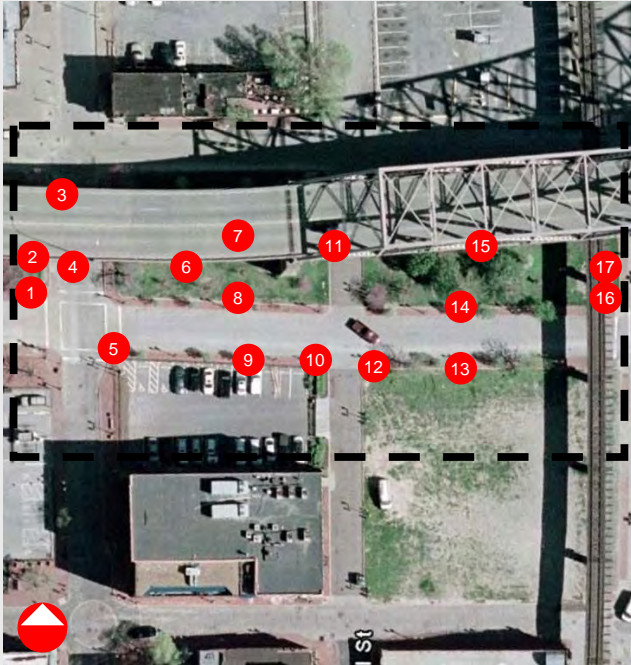
## Block 16 Laclede's Landing Blvd.

1. Ground mounted street sign missing.
2. Inlet/curb needs repair.
3. Transition between asphalt surface and cobble needs to be created with a concrete band.

9. Trees located in narrow walk adjacent to existing parking lot will be difficult to keep in this area.
10. Inlet and street sign create tripping hazard at sidewalk corner.

11. Wood retaining wall needs to be replaced.
12. Pavers at ramp need to be reset.
13. Cable and bollard barriers are ineffective and should be replaced with some other type of temporary barrier.

14. Graffiti should be removed from existing light pole.
15. Pohrer Park
  - Turf on ship berm is failing and starting to erode.
  - Signs on north side of park need to be straightened.

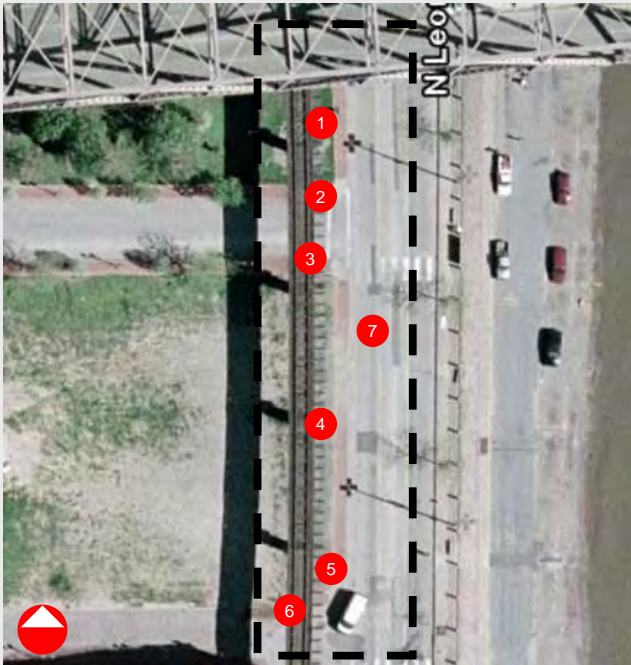
## Block 16E Leonor K. Sullivan Blvd.

1. No cobblestone treatment in R.O.W. of this area. It should be installed for consistency and to improve the overall image of the area.
2. Storm inlet is clogged with debris and should receive regular maintenance.
3. Lack of trestle bird barrier is contributing to excess pigeon refuse on area sidewalks.
4. Adjacent vacant land erosion is depositing soil and debris across sidewalks and cobblestones, restricting pedestrian circulation.
5. Sign pole needs to be straightened and repainted.
6. Unsightly erosion problem, creates a poor first impression for visitors who arrive by the riverfront.

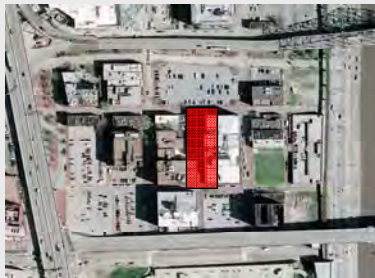
## Blocks 26W & 26E Clamorgan Alley

2. Unscreened dumpsters which should be located within the building envelope.
3. Pavement has settled or is missing adjacent to manholes creating tripping hazards.

7. Paving bricks missing at various locations, and should be replaced.
8. Nice Informal seating area, however dumpsters make area unpleasant for users.
9. Steep transition to adjacent sidewalk. Alley drainage rarely exists center of alley. Alley needs to be properly pitched or permeable pavement should be utilized.

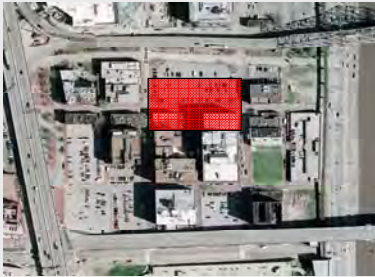
## Blocks 25 & 26 Morgan St.

1. Street trees needed on this side of street.
2. Trees heaved heaved surrounding pavement and tree grates. Several tree planting areas have missing or loose cobbles edges.
3. Newspaper box should be moved to a consolidated location with other boxes.
4. Various utility boxes need to be adjusted flush to grade.
5. Directory sign needs repainting and updated map.
6. Benches needed on this side of sidewalk.
7. Missing pavers in alley need to be replaced at various locations.
8. Banner pole adjacent to parking should include a flag pole for added visual interest at parking lot opening.
9. Missing pavers need to be replaced at various locations.
10. Various sign poles need to be repainted and straightened.
11. Traffic control gate should be painted black to match surrounding fixtures.
12. Curb needs replacement at various locations.

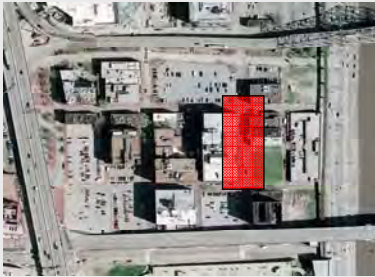
## Blocks 26E & 15W First St.

1. Intersection paving very uneven. Cobbles need to be reset and concrete banding should be replaced.
2. Brick steps should be rebuilt. Uneven pavement near steps needs to be reset.
3. Planting bed tie walls need replacement and the plantings need replacement.
4. New street trees are needed on both side of the street.
5. Paint and straighten sign poles.
6. Consolidate paper and delivery boxes into one location.
7. Additional planters would improve outdoor dining experience. Planters should match other site furnishings.
8. Multiple valve boxes need to be reset throughout area.
9. Existing benches need to be replaced.
10. Pedestrian pavement has settled and needs to be reset.
11. Handicap ramp needed on this side of street opposite existing ramp.
12. Existing banner poles should incorporate flags where possible.

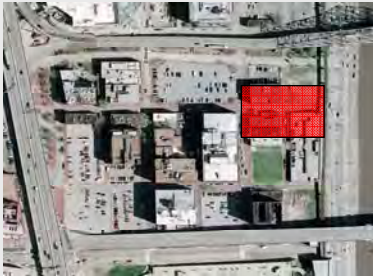
## Blocks 15 & 16 Morgan St.

1. Concrete band is major traffic barrier and should be replaced.
2. Missing light fixture needs to be replaced.
3. Sidewalk has width on this side of street to accommodate new street trees.

6. Pavement has settled around existing utility structures creating tripping hazards.
7. Asphalt overlays should be removed from street cobble stones and cobbles should be reset to create even driving surface.

8. Street trees could be added where sidewalk is wider on this side of street.
9. Existing granite curb.
10. No sidewalks exist on this side of street.
11. Non standard parking sign pole, should be replaced with consistent pole.

12. Cable and bollard barriers are ineffective and should be replaced with some other type of temporary barrier.
13. Silt collecting in this area due to erosion from adjacent vacant site.

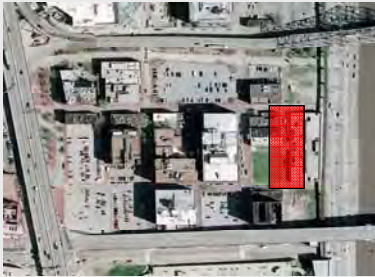
## Blocks 15E & 15W Commercial Alley

10. Wooden retaining wall failing and in need of immediate replacement.
11. Major pavement/sewer replacement needed.
12. In-ground street sign replacement needed.

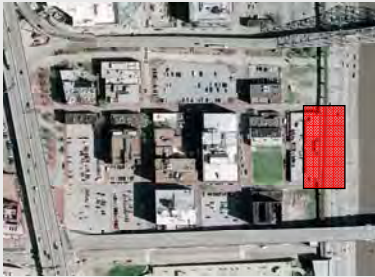
## Block 15E Leonor K. Sullivan Blvd.

- Existing sign pole is bent, needs painting and should be replaced.
- Brick paving at fire hydrant needs to be reset.
- Existing damaged parking stops project a poor image.

- Consider adding pedestrian level lighting to garage piers to provide additional ambient lighting in this area.
- Cobblestone joints in pavement are too wide, making walking difficult and potentially unsafe. Cobbles should be reset.

- Missing cobblestone should be replaced at various locations.
- Brick sidewalk has settled and does not adequately drain. Mud is covering sidewalk at several locations.

- Remove existing curb and replace with roll type curb at parking garage entrance.
- Temporary parking price sign blocks ADA access. Consider incorporating price information to existing pole sign, described above.

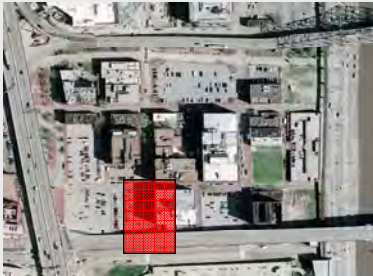
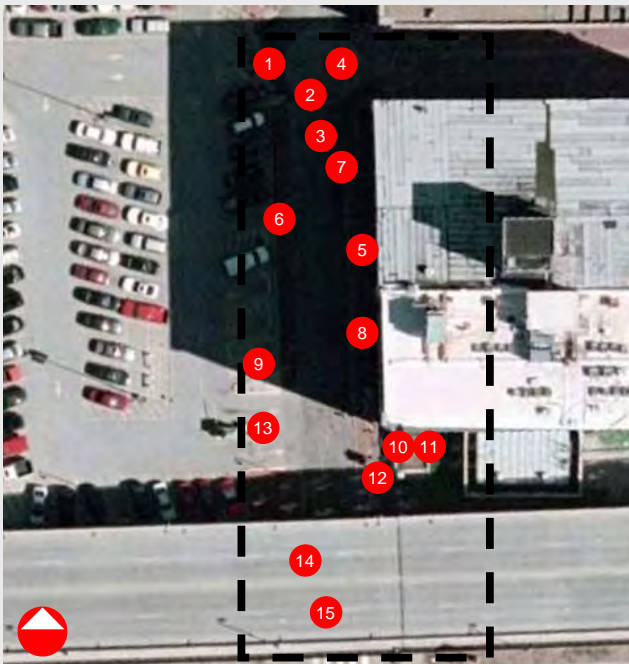
## Block 66 & 27W Second St.

1. A pedestrian oriented terminus is needed at the end of Lucas Street.
2. Circular concrete band needs replacement and uneven intersection pavers need to be reset.

3. Large concrete band with ADA ramp on one side but straight curb on opposite side.
4. Street pavement is rutted and in very bad condition. Needs cobble stone reset.

5. Benches in this area are missing and need to be replaced. Plant larger trees in a continuous bed to provide improved growing conditions. Replace missing tree grate or add plantings to open area.

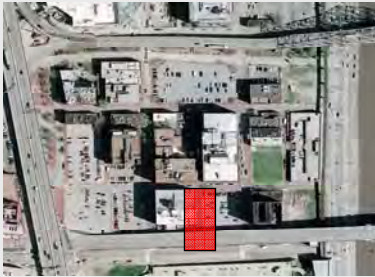
## Blocks 27W & 27E Clamorgan Alley

1. Poorly defined edge of parking lot. No buffer or screening.
2. Temporary wood stairs should be replaced with permanent brick solution.
3. Utilities are generally well screened in this alley.

4. Alley pavement has been patched with concrete and asphalt in various locations. Patches should be removed and replacement brick pavers installed.
5. Bollard and cable barrier projects poor impression. Replace with black metal fence similar to that on other edges of the adjacent parking lot.

9. Inlet is in poor condition, and pavement around storm inlet has settled preventing adequate drainage.
10. Poor view into utility service area. Needs to be screened.

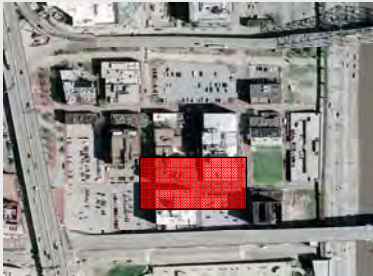
## Blocks 26 & 27 Lucas Ave.

1. Cobble street pavement very uneven, resetting needed.
2. Fire hydrant blocks corner sidewalk access.
3. Valve boxes and horizontal street signs create multiple tripping hazards.

7. Abandoned sign post should be removed or utilized.
8. Alley pavement surface in poor condition with steep cross slope.
9. Uneven pavement at all manholes is a serious tripping hazard.

10. Inlet grate is a tripping hazard and needs replacement.
11. Street light placement in center of sidewalk seriously compromises usefulness of sidewalk.

12. Mature trees have disrupted pavement. Trees should be replaced and pavement reset.
13. Benches need replacement in this section of sidewalk.
14. Parking lot edge constructed of asphalt which is crumbling. A new edge is needed.

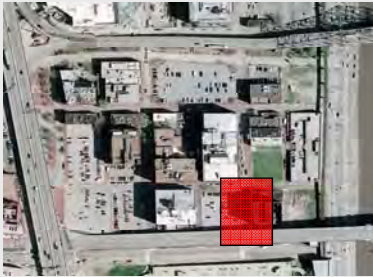
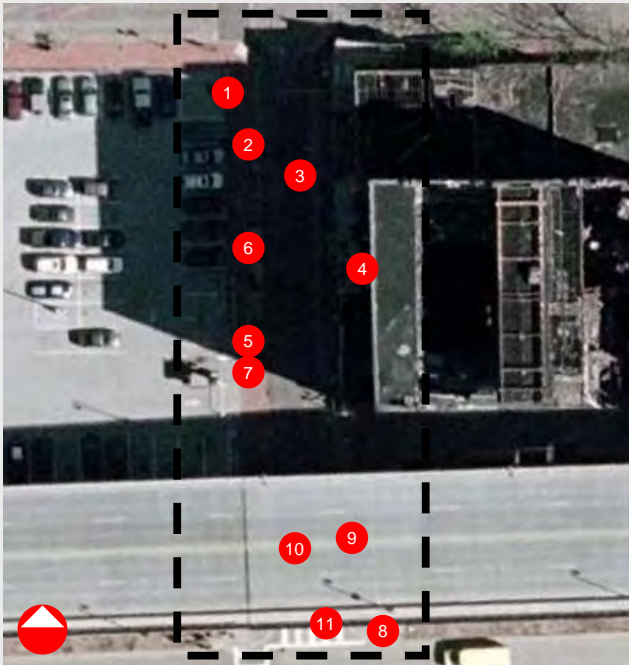
## Block 27E & 14W First St.

1. Asphalt curb along parking lot fence should be replaced. Fence needs to be removed and reset. Street trees completely missing and should be replaced in this section for First Street.

2. Curbing needs replacement and street pavement needs to be reset.
3. Sidewalk in front of Switzer Building site is gone and needs to be replaced. Due to building removal, a barrier fence will also be needed.

6. Damaged planters should be replaced. Replacement planters should match surrounding architectural style
7. Temporary parking signs located on sidewalk need to be removed from sidewalk.

8. Roadway pavement under Eads Bridge is in very bad shape and needs to be reset.
9. Area beneath Eads Bridge is filthy. Overhead structure should be modified to prevent accumulation of pigeon droppings.

10. Consider adding attractive entry signage to Eads Bridge structure at portal entrance.

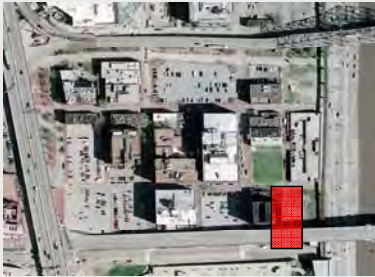
## Blocks 14W & 14E Commercial Alley

1. Access to alley is completely restricted due to a construction fenced placed around the Switzer Building site.
2. All pedestrian lighting has been removed from this alley during the demolition of the Switzer Building. Lighting which matches the historic lighting used throughout the Landing should be used as replacement lighting.
3. Only a small portion of the existing alley curbing remains. New curbing should be installed when property is redeveloped, or when construction fence is removed.
4. Alley pavement is generally in good shape and does not need replacement.
5. Eads Bridge portal is clean but needs graffiti removal and painting. Consider adding attractive entry signage at portal entrance.
6. Replace missing lighting fixtures to provide adequate lighting in portal area.

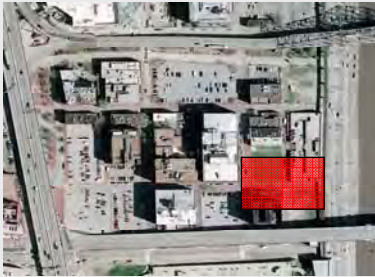
## Blocks 14 & 15 Lucas Ave.

1. Cobble street pavement very uneven especially at manholes.
2. Existing iron columns embedded in building foundation wall are a hazard and should be removed. A safety barrier rail is needed along entire length of remaining foundation wall.

4. This section of Lucas Ave. has a very steep slope. ADA slope guidelines can not be met on this sidewalk.
5. Mature trees have disrupted pavement surface. Trees should be replaced and pavement repaired.

11. Electric boxes need to be reset flush to surrounding pavement to eliminate tripping hazard.

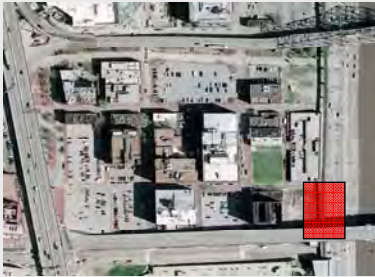
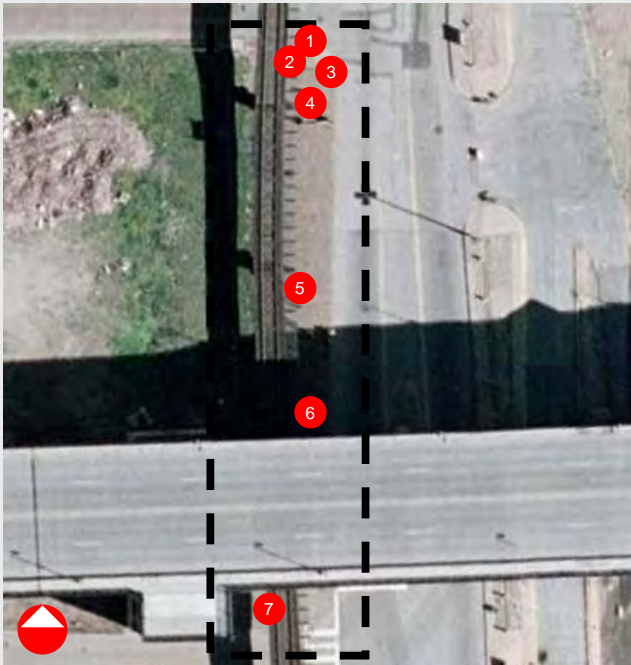
## Block 14E Leonor K. Sullivan Blvd.

1. Pavement adjacent to traffic signal boxes has settled and needs to be reset. Inlet also needs new lid.
2. Small portion of cobble area needs to be reset.
3. Street sign needs to be realigned to proper streets.
4. Directory needs to be cleaned of mud so sign is legible.
5. Mud from adjacent property is covering cobble stones. Erosion control from adjacent property should be installed and maintained.
6. Public art is in a low visibility area, and should be relocated to a higher visibility location.
7. Highly visible, but neglected area should include signage and planters to serve as a point of welcome to the Landing.

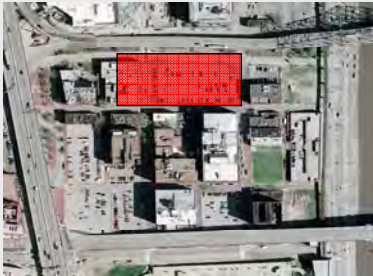
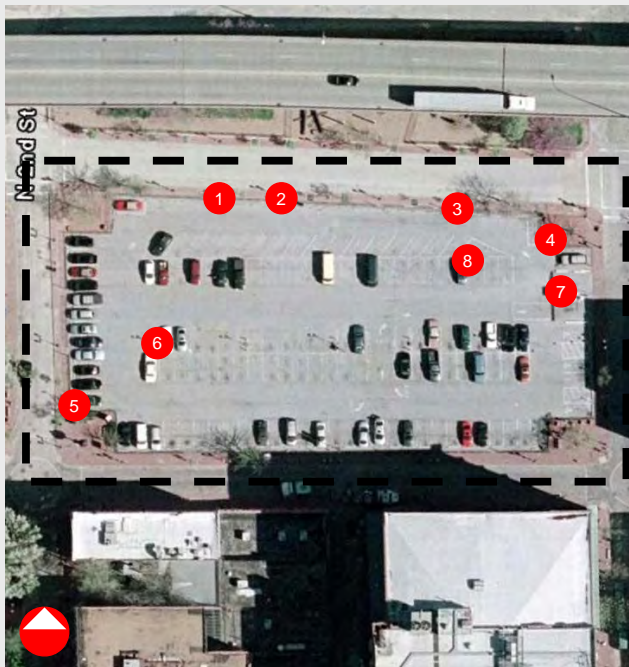
## Block 25 Parking Lot

1. Pedestrian access opening marked by taller posts. Banners would add visual interest.
2. Secondary supports indicate fence will require remounting in the future.
3. Scattered curb stops used to define edge of lot. Trash cans do not match style of others used throughout the Landing.
4. Supply storage box should be screened.
5. Electric meter should be screened from view.
6. Parking lot lights do not match landing style of lights used in landing.
7. Attendant booth should reflect some elements of architectural style of area.
8. Planting island are completely lacking in this parking lot.
